Cracks in the box girders of Bongobondhu Jamuna Multipurpose Bridge- Identification of causes based on FE analysis

K.M. Amanat, A.F.M.S. Amin, T.R. Hossain, A. Kabir & M.A. Rouf
Bangladesh University of Engineering and Technology, Dhaka 1000, Bangladesh

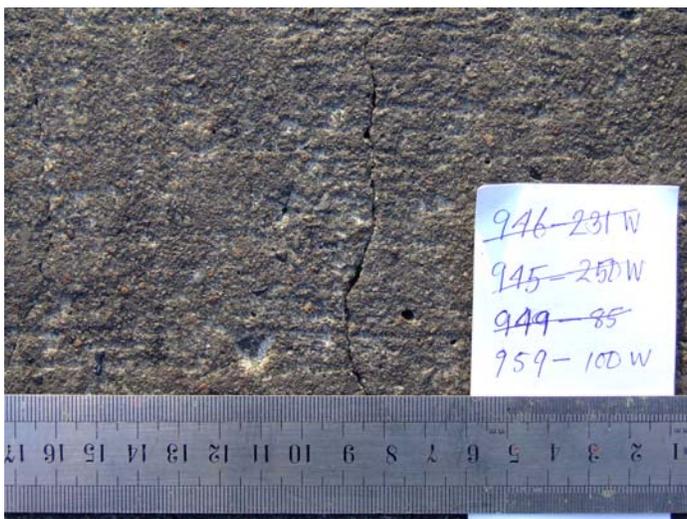
Figure 1. Longitudinal cracks along the box centre line (at top surface of the deck). Segment number: 959. Photo taken on 23 March 2006.

Distinct, more or less straight longitudinal cracks were observed in the top of the deck slab at centre of the boxes. Similar cracks had been detected in some of the segments quite early during erection of the bridge segments (RPT-NEDCO-BCL, January, 1998). It is believed that these cracks have been initiated by shrinkage of concrete between two webs. Later they got widened due to temperature effects. Further, they got prominence due to negative temperature gradient (deck top colder than inside). BUET Consultant from their 3-D analysis obtained tension over 2.5 MPa at the top side of box centre under self weight and temperature gradient. RPT, 1998 report also explained that cooling of the exterior surface of the bridge deck due to sudden drop in temperature. These crack width are getting wider quite fast recently and has reached nearly 0.5 mm width as per reports of Marga Net One Ltd.

- (a) Appropriate measures should be taken immediately to seal the cracks on the deck and lay 50 mm wearing course with material that can take significant tension and is abrasion-resistant.

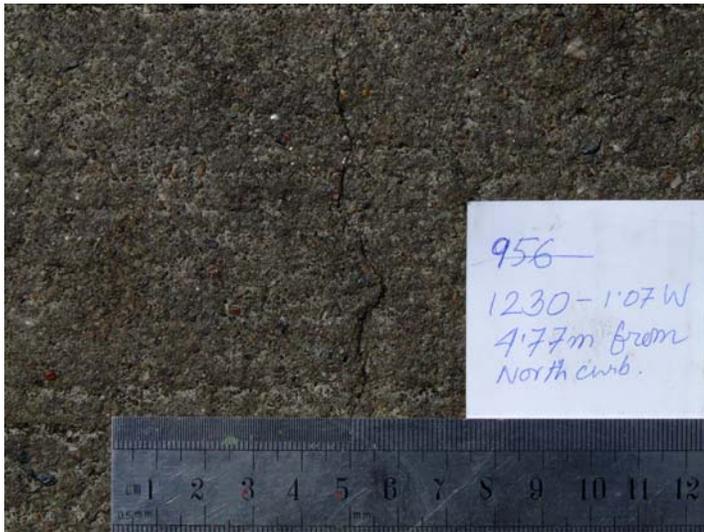
Figure 2. Longitudinal cracks along the box centre line (at top surface of the deck) (at top surface of the deck). Segment number: 1230. Photo taken on 24 March 2006.

A longitudinal crack observed at the bottom face of the deck slab in segment 1230. It is located at half way between the boxwebs. The crack appeared to be very fine. However, the top surface of the deck over this crack is also cracked in the longitudinal direction. This indicates that the top crack may have penetrated through the total depth of the deck slab. Such cracks at the soffit of top slab are not reported in any other segment of the bridge. It is anticipated that it is an incidental happening perhaps due early shrinkage cracks which extended across the depth.

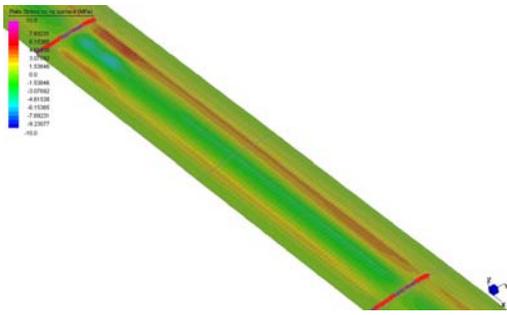
Figure 14. Transverse fiber stress contour on the top of deck for load combination 4 near pier

However, it needs mentioning that 30 unit HB load along with appropriate HA loading combinations has been found to produce significant tension in the deck top adjacent to the inside face of the south web. So, it may be viewed as a design deficiency.

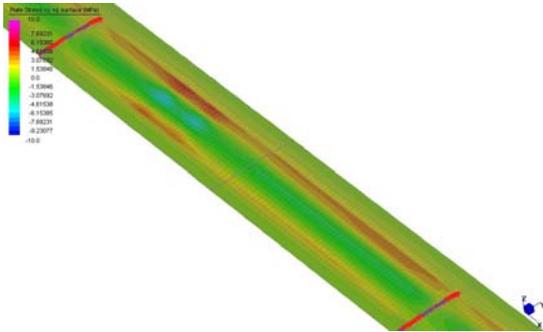
Figure 15. Transverse fiber stress contour on the top of deck for load combination 4 at quarter span

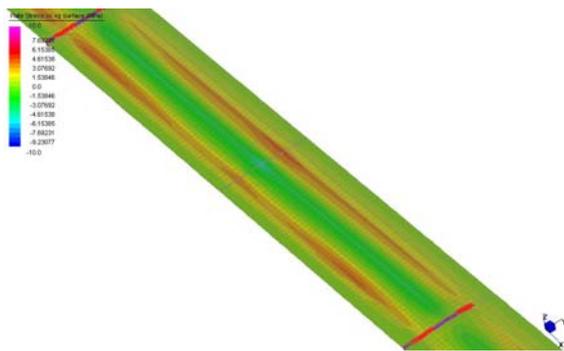
Figure 16. Transverse fiber stress contour on the top of deck for load combination 7 at mid-span

The second inadequacy appears to be inappropriate assessment of negative temperature gradient effect. A sudden drop of deck slab temperature by 10° C compared to the bottom of the deck slab is found to produce tensile stress close to 3 MPa at the top of the deck slab at the centre of box. Hence, the top longitudinal crack at the centre of the deck slab was inevitable. The BS 5400 prescribes similar (about 8°C) negative gradient for deck slabs. But the designer seems to have made some averaging assumption which reduced it to 4°C within the depth of top slab.
