Shift in the natural frequencies of the deck of Bangabandhu Jamuna bridge due to CFRP strengthening

A.F.M.S. Amin, M.M. Islam, N. Fuad, M.S.I. Choudhury, A. Hasnat & K.M. Amanat
Bangladesh University of Engineering & Technology, Dhaka, Bangladesh

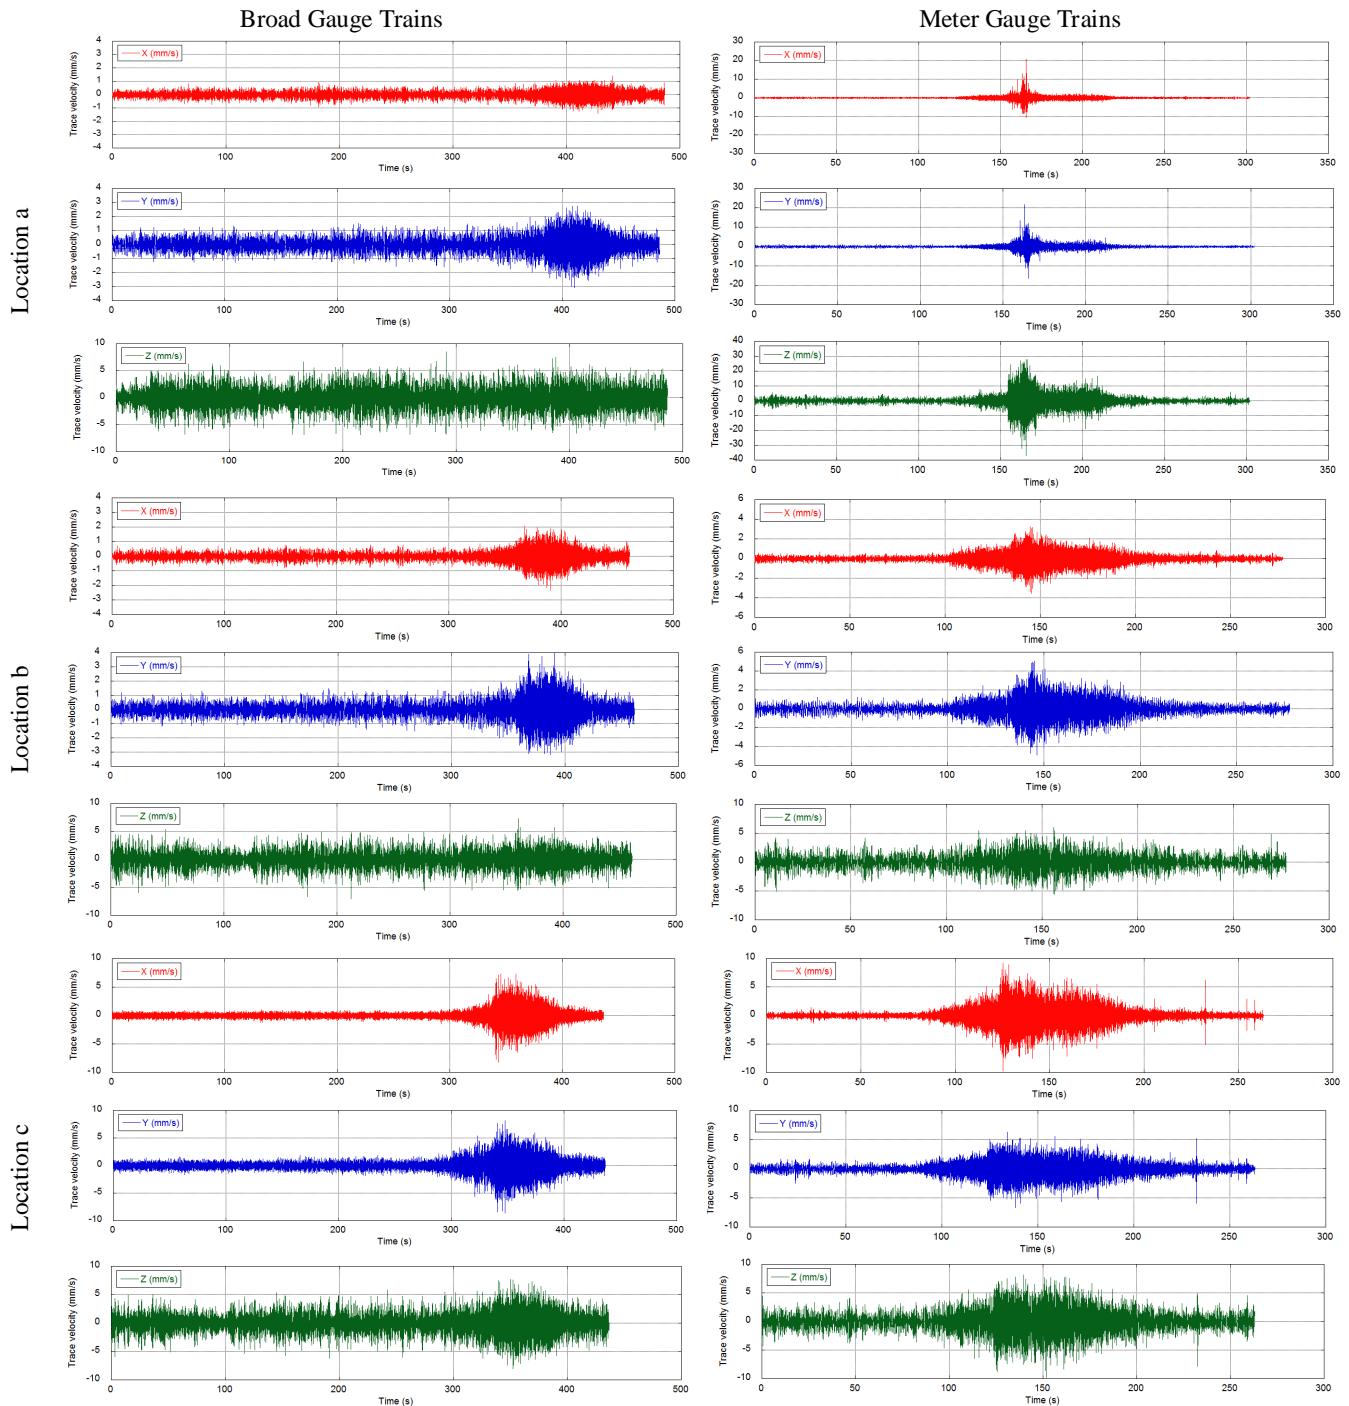
Figure 5 presents the comparison for x, y and z axes measurements. A trace data clearly shows significantly larger vibration in all measurement locations and all axes for the meter gauge trains. The broad gauge trains, although have larger static wheel loads, induces smaller vibration amplitudes due to greater stability achieved from wider axels.

Figure 5. Typical vibration records for broad gauge and meter gauge trains at mid-span locations (Measurement Section 3, Figures 1-3)

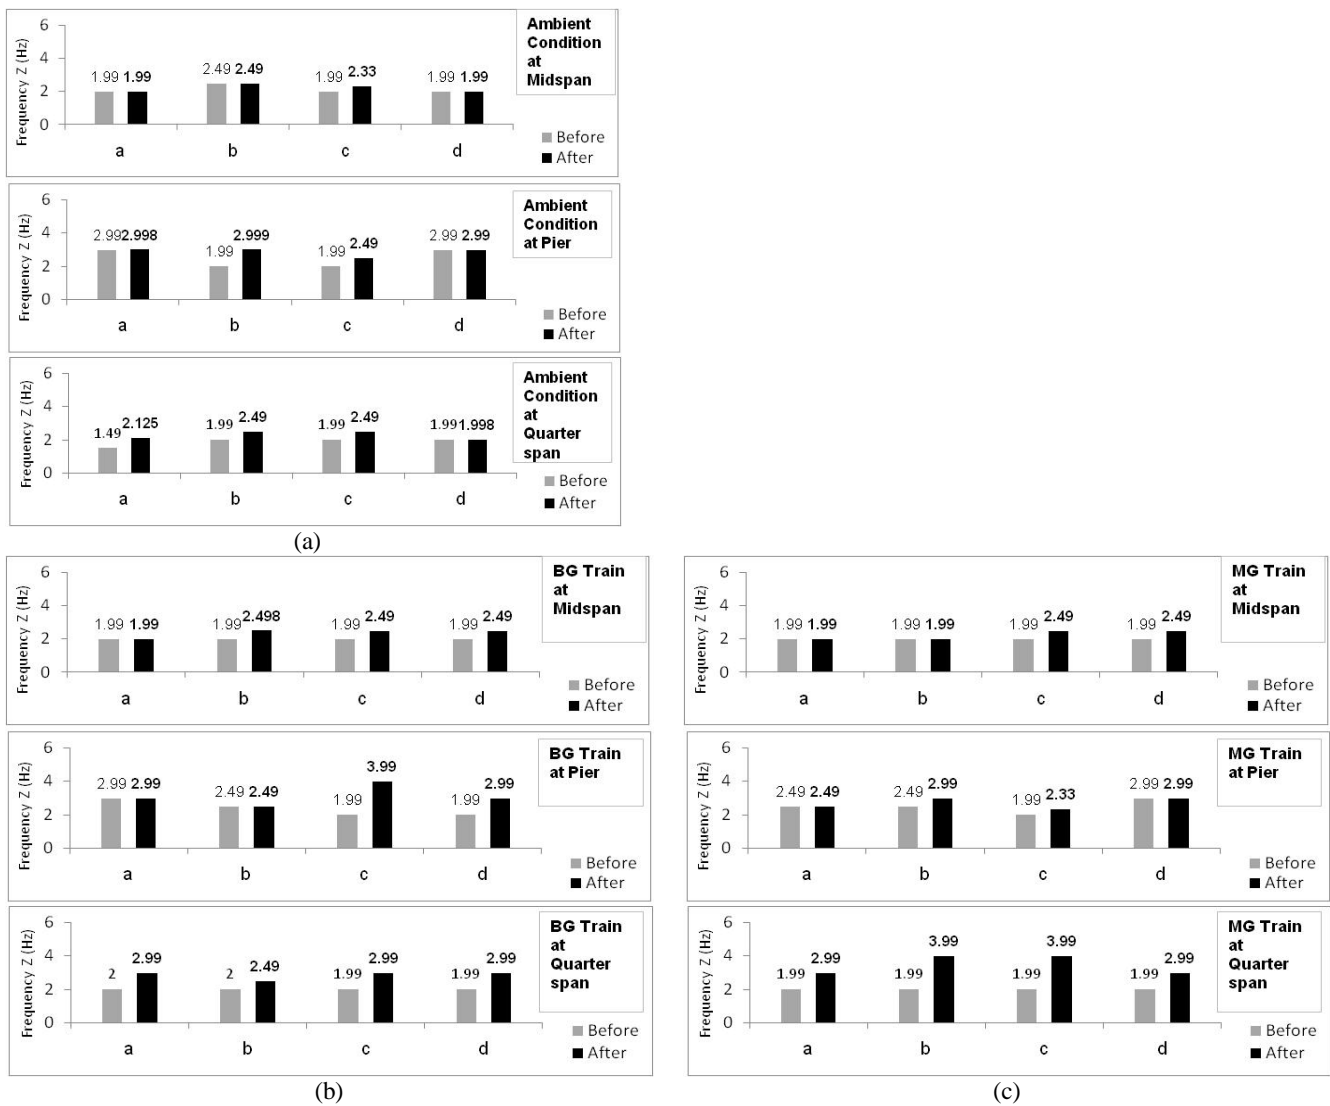
A preliminary evaluation of the fundamental natural frequencies at each of the locations for Z-direction is compared in Figure 6 by analyzing the measurements taken before (bare and cracked concrete) and after strengthening conditions. The measurements taken due to excitation from ambient vibration are compared with those due to broad gauge and meter gauge trains. At present, a train takes about 20 to 30 min to cross a bridge.

Figure 6. Fundamental natural frequencies obtained from field vibration measurements. (a) Ambient condition, (b) Excitation due to broad gauge train, (c) Excitation due to meter gauge train
