## Cracks in the box girders of Bongobondhu Jamuna Multipurpose Bridge- Identification of causes based on FE analysis

K.M. Amanat, A.F.M.S. Amin, T.R. Hossain, A. Kabir & M.A. Rouf  
*Bangladesh University of Engineering and Technology, Dhaka 1000, Bangladesh*

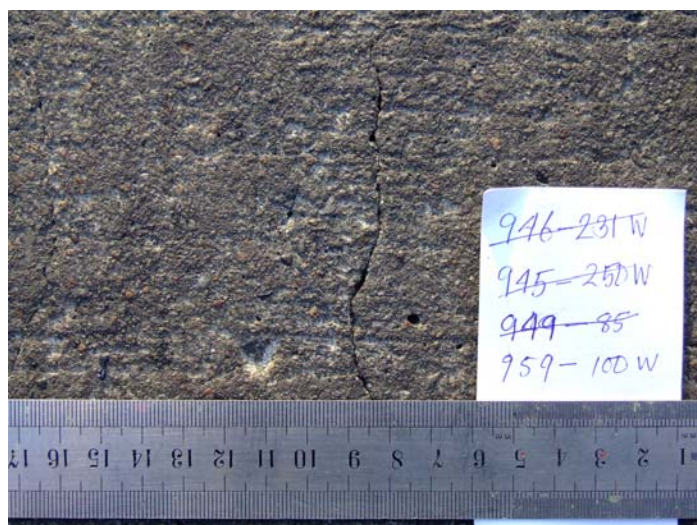
Figure 1. Longitudinal cracks along the box centre line (at top surface of the deck). Segment number: 959. Photo taken on 23 March 2006.

Distinct, more or less straight longitudinal cracks were observed in the top of the deck slab at centre of the boxes. Similar cracks had been detected in some of the segments quite early during erection of the bridge segments (RPT-NEDCO-BCL, January, 1998). It is believed that these cracks have been initiated by shrinkage of concrete between two webs. Later they got widened due to temperature effects. Further, they got prominence due to negative temperature gradient (deck top colder than inside). BUET Consultant from their 3-D analysis obtained tension over 2.5 MPa at the top side of box centre under self weight and temperature gradient. RPT, 1998 report also explained that cooling of the exterior surface of the bridge deck due to sudden drop in temperature. These crack width are getting wider quite fast recently and has reached nearly 0.5 mm width as per reports of Marga Net One Ltd.

- (a) Appropriate measures should be taken immediately to seal the cracks on the deck and lay 50 mm wearing course with material that can take significant tension and is abrasion-resistant.

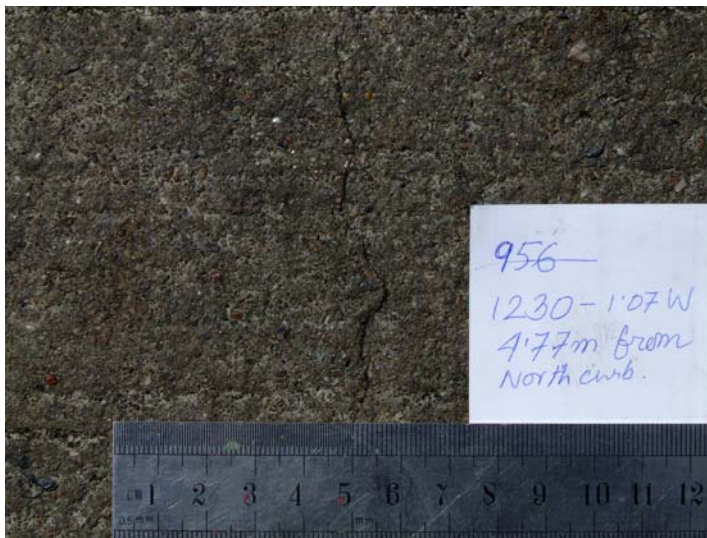
Figure 2. Longitudinal cracks along the box centre line (at top surface of the deck) (at top surface of the deck). Segment number: 1230. Photo taken on 24 March 2006.

A longitudinal crack observed at the bottom face of the deck slab in segment 1230. It is located at half way between the boxwebs. The crack appeared to be very fine. However, the top surface of the deck over this crack is also cracked in the longitudinal direction. This indicates that the top crack may have penetrated through the total depth of the deck slab. Such cracks at the soffit of top slab are not reported in any other segment of the bridge. It is anticipated that it is an incidental happening perhaps due early shrinkage cracks which extended across the depth.

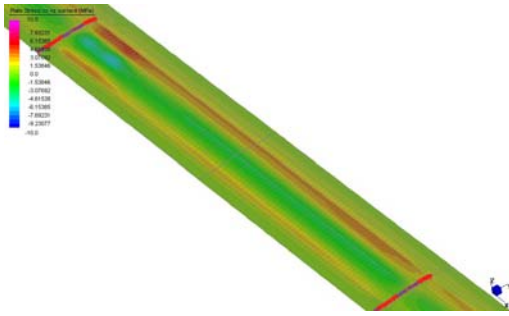
Figure 14. Transverse fiber stress contour on the top of deck for load combination 4 near pier

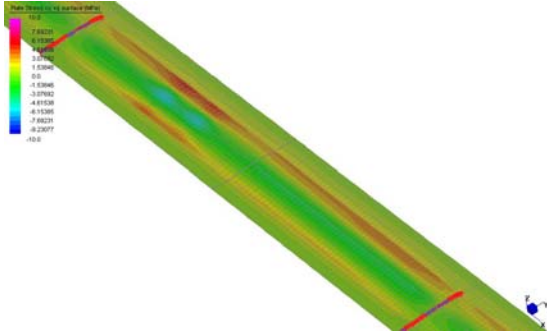
Figure 15. Transverse fiber stress contour on the top of deck for load combination 4 at quarter span

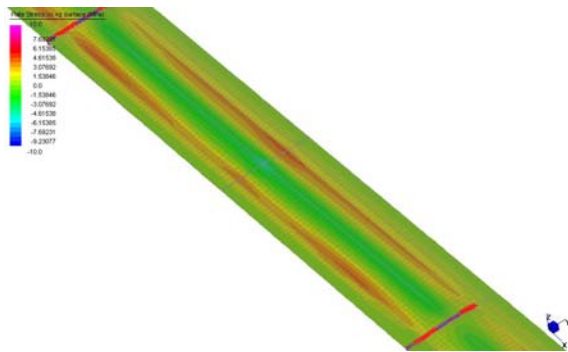
Figure 16 Transverse fiber stress contour on the top of deck for load combination 7 at mid-span

The second inadequacy appears to be inappropriate assessment of negative temperature gradient effect. A sudden drop of deck slab temperature by 10° C compared to the bottom of the deck slab is found to produce tensile stress close to 3 MPa at the top of the deck slab at the centre of box. Hence, the top longitudinal crack at the centre of the deck slab was inevitable. The BS 5400 prescribes similar (about 8°C) negative gradient for deck slabs. But the designer seems to have made some averaging assumption which reduced it to 4°C within the depth of top slab.
