Experimental investigation on dynamic characteristics of Meghna bridge at different structural conditions

Conference Paper · August 2015

M.S.I. Choudhury & R. Tobita

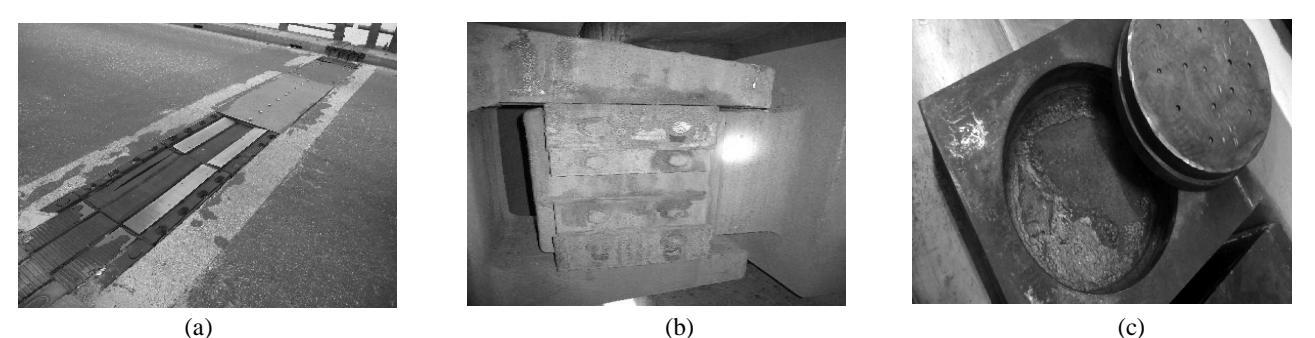
The Meghna Bridge is a pre-stressed concrete box girder balanced cantilever bridge located over the Meghna River of Bangladesh. It was the first application of segmental bridge construction technique in Bangladesh. The necessity for constructing the Meghna Bridge was to increase the economic activity of the two major cities of Bangladesh by removing the bottle-neck at the ferries. It was constructed as a part of a Dhaka-Chittagong National Highway (N1) in Bangladesh. The 257 km long Dhaka-Chittagong National Highway is a part of the Asian Highway. In 2011, the Dhaka-Chittagong National Highway (N1) almost exceeded its traffic volume capacity to 25,000 AADT (Annual Average Daily Traffic) counted at the approach of Kanchpur, Meghna and Meghna-Gumti bridges (Tatsumi, 2012) but, in 1997, it was 10,000 only and 80% of the traffic are heavy vehicles including bus and truck. Due to severe traffic loading and lack of maintenance, the Meghna Bridge suffered damages in central hinges and rubber expansion joints. Figure 1 shows damaged expansion joints and non-functioning central hinge. Most of bearings and expansion joints were damaged permanently.

Significant vibrations were induced by vehicles passing over the expansion joints at central hinges possibly due to those changed boundary conditions, which were perceivable and warranted an emergency maintenance operation. Emergency repairing works were done to overcome the problem. Before and after the repairing works, field vibration measurements were made to determine the model properties of Meghna Bridge with different structural conditions. The effect of repairing works could be understood from the dynamic characteristics of the bridge. There have been many researches on modal testing of different types of bridges such as balanced cantilever bridges, cable-stayed bridges, historical masonry bridges, suspension bridges, railway bridges, highway bridges and timber bridges. Altunisik et al. (2011) performed output only system identification of post-tensioned Gülburnu Highway Bridge located on the Giresun-Espiye state highway to determine the dynamic characteristics using ambient vibration testing and finite-element method. Balanced cantilever method with cast-in place construction technique was applied to construct the Gülburnu Highway Bridge. The total length of the bridge is 330 m with a main span of 165 m. Vibration characteristics of reinforced concrete box

Figure 1. Identified problems of Meghna Bridge (a) damaged expansion joints, (b) non-functioning central hinge and (c) damaged pot bearing.
