Renovation of two century-old steel truss railway bridges to increase the vertical clearance

A.F.M.S. Amin, K.M. Amanat & R. Ahsan

Bangladesh University of Engineering and Technology, Dhaka 1000, Bangladesh

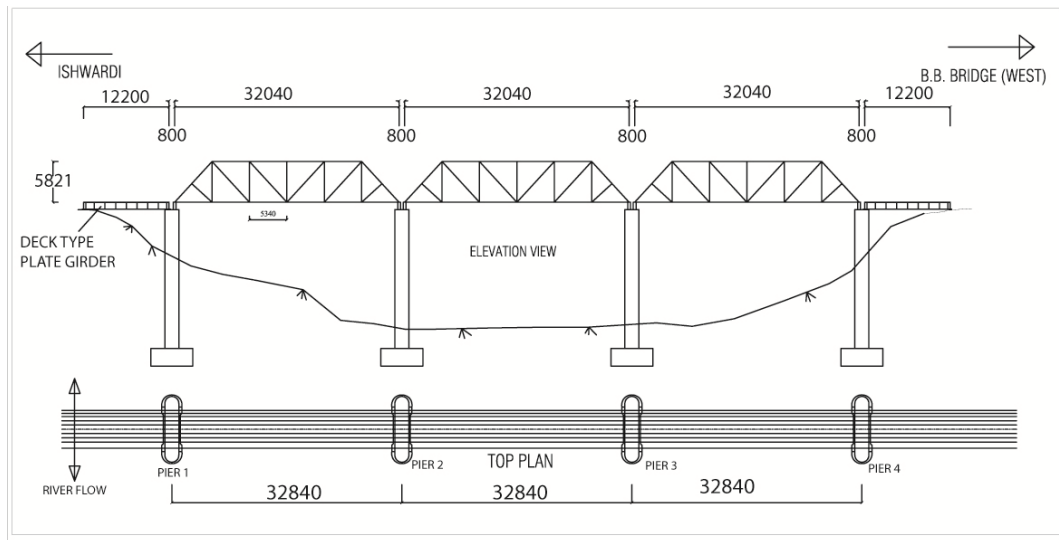
Figure 4. General dimensions of Boral Bridge and span arrangements

Removal of the top wind bracings of an existing railway steel truss bridge and installing a new bracing system with greater vertical clearance without affecting the vertical load carrying capacity of the trusses is undoubtedly a specialized kind of job requiring a thorough understanding of the structural behavior of the 100-year old structure. In order to get a first-hand idea about the existing condition of the bridges, the bridge superstructures were thoroughly inspected. Due to the absence of any design drawings for these bridges, it was necessary to survey the bridges thoroughly and prepare as-built drawings for the major elements of the superstructure. In this context, the preparation of as-built drawing for major members for member sizes, engineering analysis and design detailing for the top bracing replacement work was done (Figure 4).

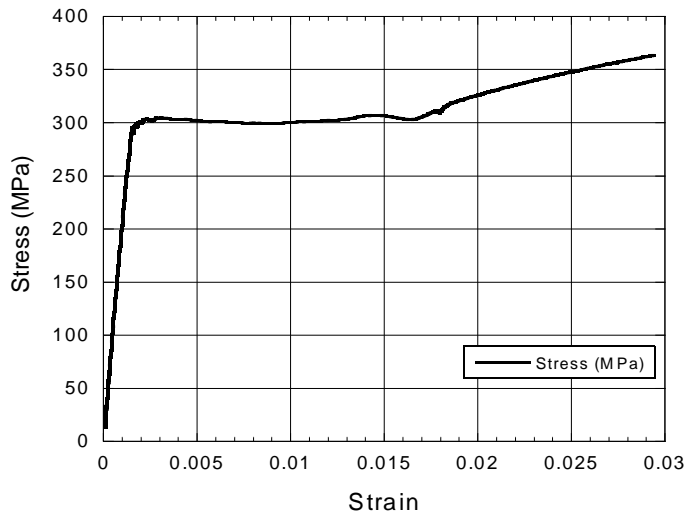
The railway bridges served for about 100 years. It was therefore considered to check the residual ductility of the existing members to ascertain any loss due to fatigue that might have taken place due to use over the time. Figure 5 presents a typical stress strain response of the steel extracted from the main load bearing members of the bridge. It shows the yield strength to be of the order of 300 MPa and ultimate elongation around 3%. No vertical sag in the existing bridge was noticed.

Figure 5. Stress-strain response of existing members

An illustration of the existing top plan bracing and the suggested new bracing system is shown in Figure 6. Three dimensional finite element models of the structural system of a typical span of the existing bridge was developed to find out the stresses in members due to different combinations of vertical load and wind load. Site specific wind load was assigned according to design wind speeds suggested in Bangladesh National Building Code (BNBC 2006). Numerical models for the bridge span after renovation were also developed. The member stresses and support reactions between the old and new system were compared. Material properties of the existing members have been assigned based on the tension tests performed (Figure 5). Adequacy of capacity of the renovated configuration was checked against AISC ASD 2005 provisions.

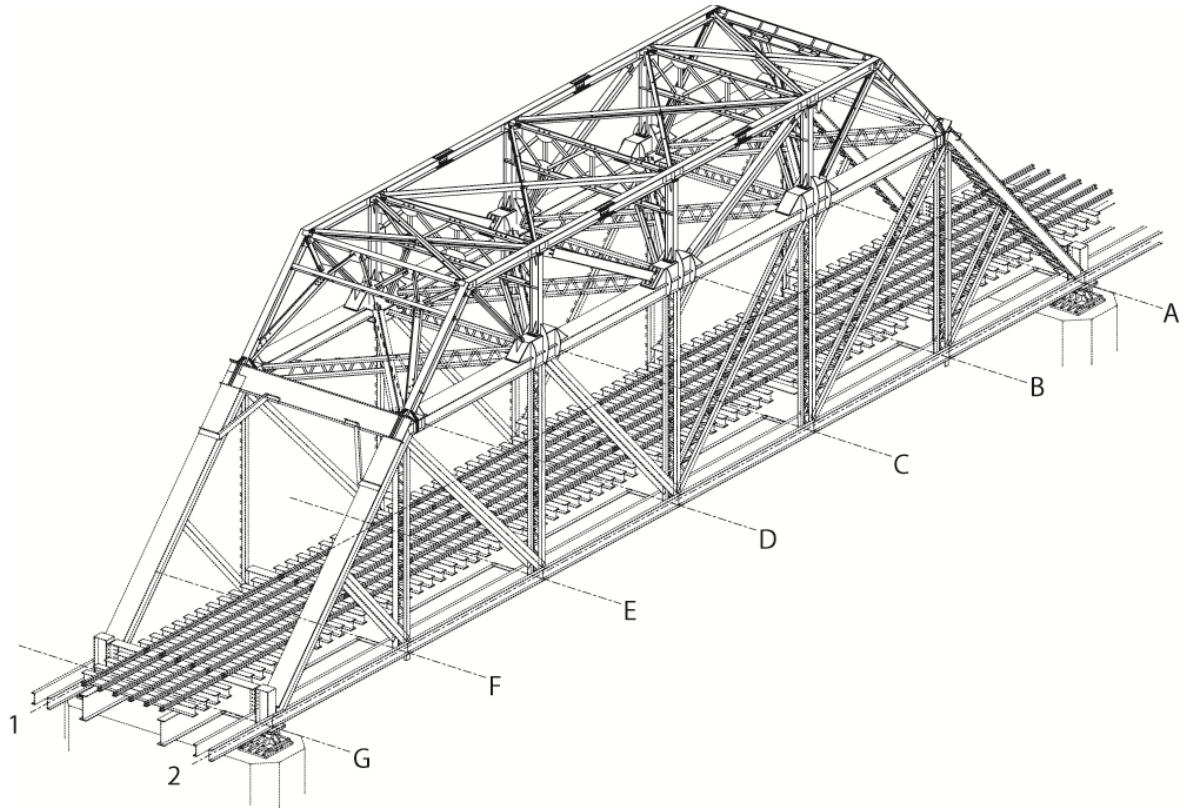
Figure 6. Post-survey reconstructed shop drawings and renovation plan for a typical span

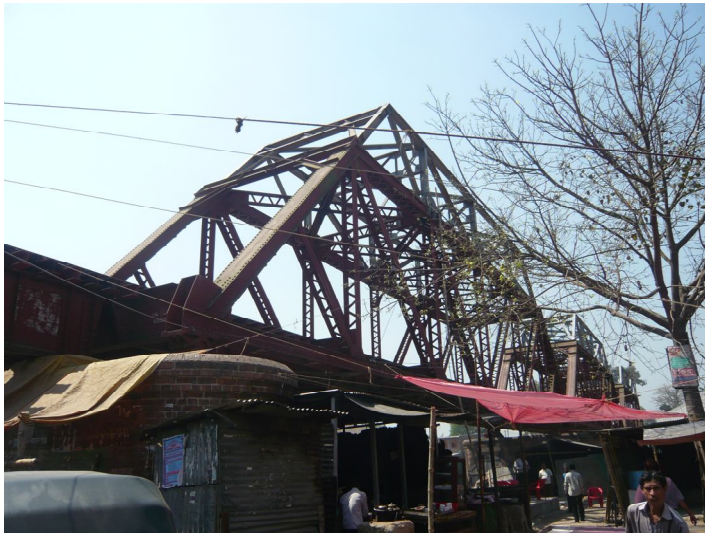
Figure 7. Boral bridge after installation of new top chord bracing system.

Figures 7-9 shows the different phases of construction of renovation works in Boral and Koidanga Bridges. Figure 8 particularly illustrates the increased clearance in Koidanga Bridge after removal of the old top chord bracing system. Figure 10 illustrates the connection details between the old and new members done through welding. The whole work was being done in different work windows on daily basis keeping the rail tracks operational for the rest of the day

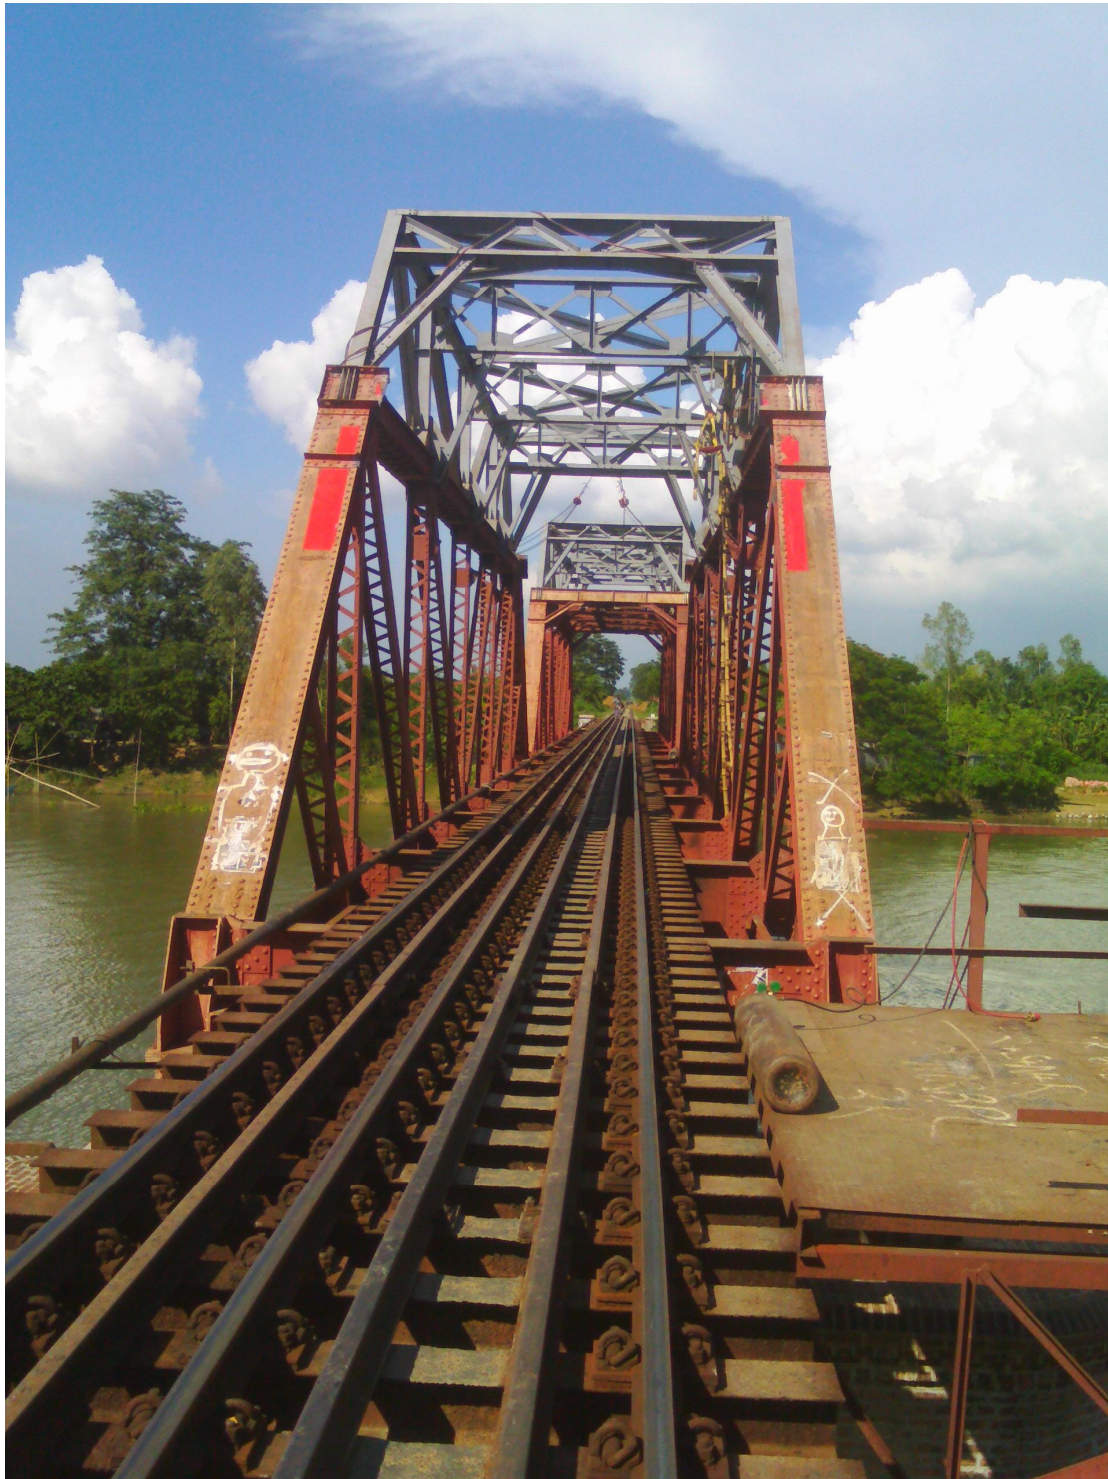
Figure 8. Koidanga Bridge after instillation of the new top chord bracing system.

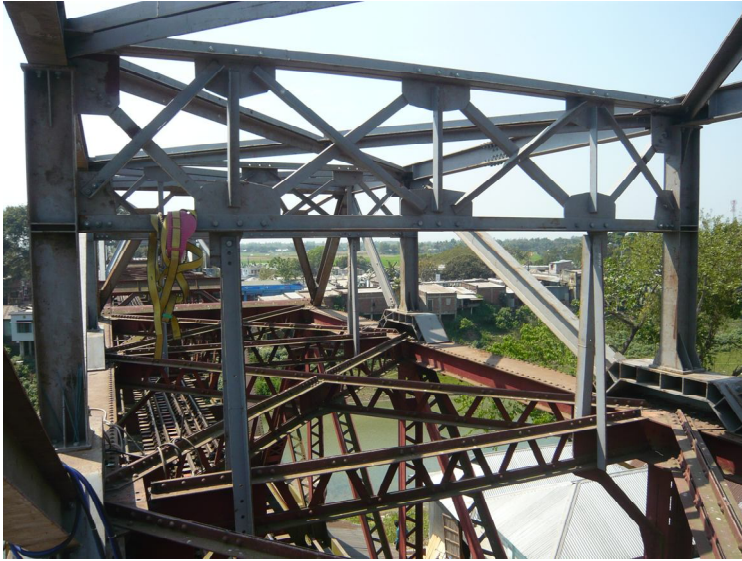
Figure 9. A view of the new top chord bracing system after installation above the old bracing system.

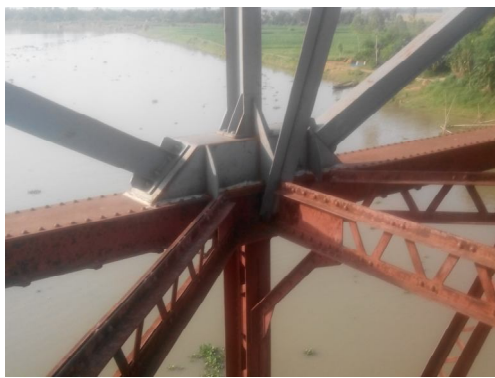
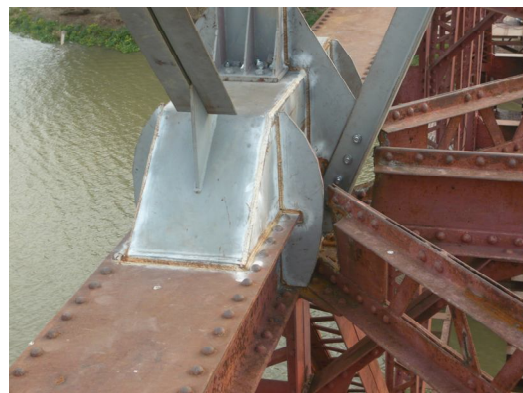
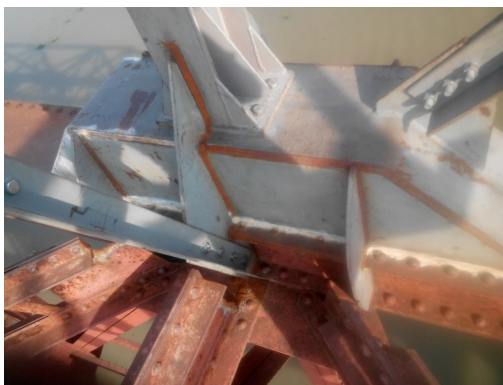
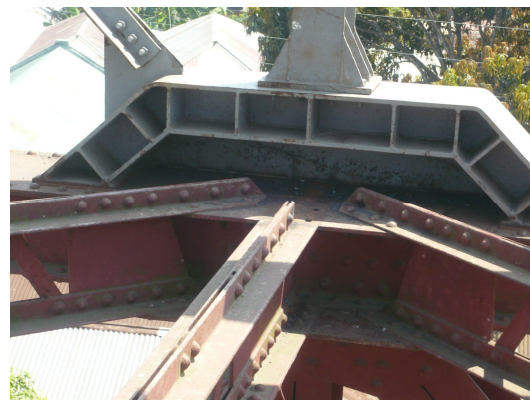
Figure 10. Details of under-construction connection between the existing top chord and the new member

It was noted to be extremely important that capacity of the existing members of the bridges should in no circumstances be impaired while conducting the renovation works. Especially net area of the top chords must not be reduced while attaching the rigid frame to the existing bridge. It is strongly recommended that the new (proposed) top bracing system be first attached to the original (existing) top-chord of the truss by means of welding only. Thereafter, the old top bracing system may be detached by means of gas-arc cutting.
