Experimental investigation on dynamic characteristics of Meghna bridge at different structural conditions

Conference Paper · August 2015

M.S.I. Choudhury & R. Tobita

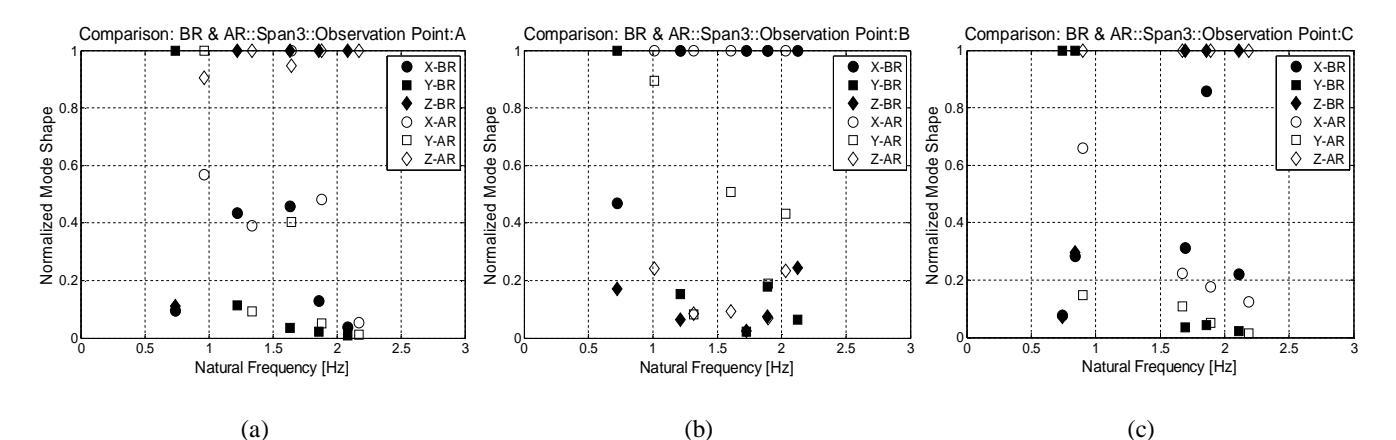
In order to understand the effect of repair on modal properties, the dynamic characteristics of the bridge identified from the recorded data were compared before and after temporary repairing work. Tables 1 and 2 summarize the natural frequencies and dominant directions of first three vibration modes of SECTION 3 and SEC-TION 8 attained from the data obtained at a single location before and after temporary repairing work. In the tables, the dominant directions of vibration modes were selected if the corresponding component in the modal vector normalized by its maximum component was greater than 0.9. Examples of the normalized modal vectors are shown in Figures 7 and 8. From Tables 1 and 2, it can be observed that the natural frequencies of the first three vibration modes at frequencies between 0.65 Hz and 2.25 Hz have been changed along with the dominant directions of 1st vibration mode. The mode shapes of the first three vibration modes were obtained from synchronized data, but there can be error in modal properties, particularly phases, because the process of synchronization by cross correlation technique cannot synchronize the time-history data series completely. Figure 9 shows time histories recorded by three sensors placed at three different locations. It can be observed in Figure 9 that before synchronization there were time lags among the sensors but after synchronization there was no obvious time lag. The peaks of all three time histories are indicated through an arrow line. However, the reduction of time lags does not mean the data have been synchronized and, therefore, vibration mode shapes obtained from the synchronized data summarized in Table 3 can be erroneous. It can be observed from Table 3 that the 1st vibration mode shape after temporary repairing work seems to be different from the mode shape before repairing but the other two vibration modes have not been affected significantly by repairing works. This could be happened because, after temporary repairing, the dominant direction of that particular mode has been changed to longitudinal and vertical direction (Table 1). Because the insertion of steel plates on the expansion joints were not properly designed considering the horizontal movement of the bridge, it was confirmed that, when vehicle passed over the expansion joints, the nuts and bolts of the joints of placed steel plates were over-stressed and failed at several times. However, due to the replacement of damaged pot bearings by rubber bearings, the transfer of the vertical load to the adjacent spans worked at a certain degree. Therefore, it can be concluded from the above explanation that, after temporary repairing, the integrity of the whole structure have been increased at a certain degree due to the replacement of damaged pot bearings by rubber bearings at central hinges.

Figure 7. Natural frequencies, normalized mode shapes and dominant directions of some principle vibration modes of SEC-TION 3 at (a) Observation point A, (b) Observation point B, and (c) Observation point C.

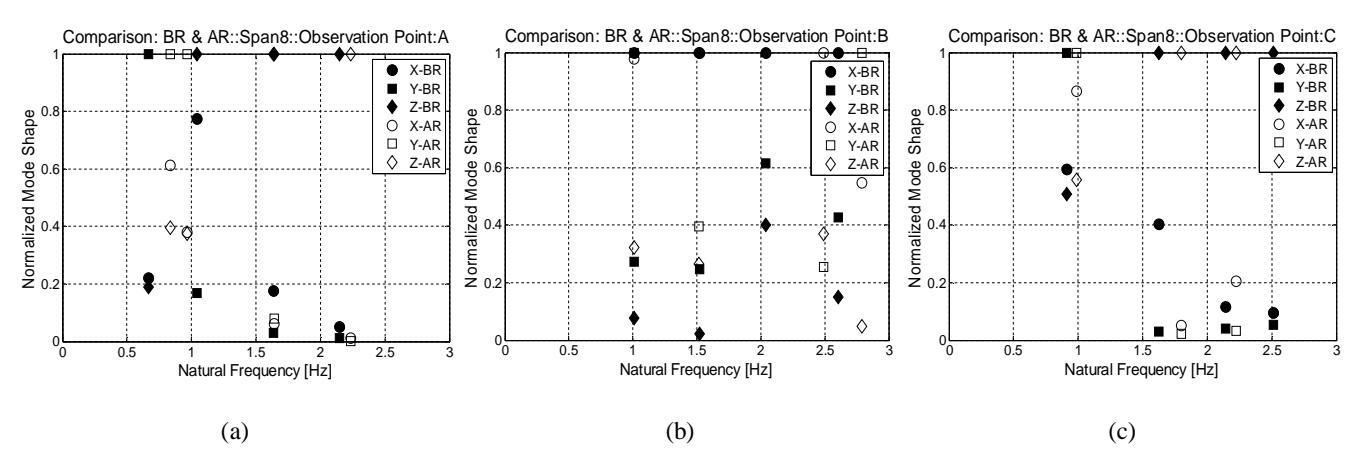
Figure 8. Natural frequencies, normalized mode shapes and dominant directions of some principle vibration modes of SEC-TION 8 at (a) Observation point A, (b) Observation point B, and (c) Observation point C.
